PROPERTY INSPECTION REPORT

Concerning: 123 Anytown USA
(Address or Other Identification of Inspected Property)

By: Terry Loftis TREC#7236 08/10/10
(Name and License Number of Inspector) (Date)

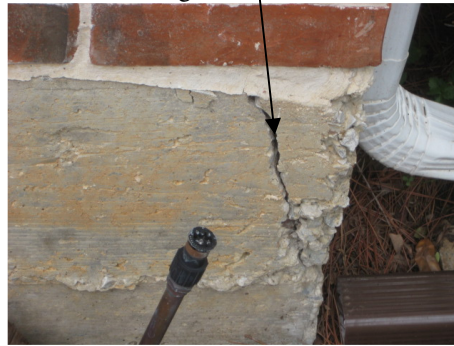
There is a corner crack at the right rear. Recommend sealing to prevent insect intrusion.

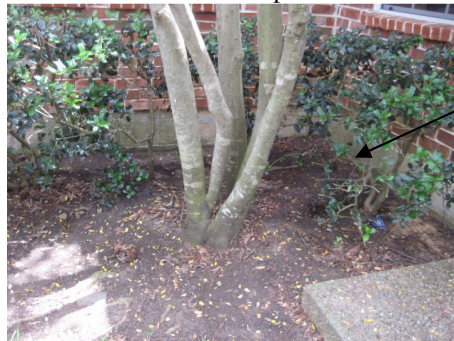
Comments: It is recommended to add additional soil to the rear of the structure along the foundation. This will allow a positive flow away from the foundation and prevent ponding.

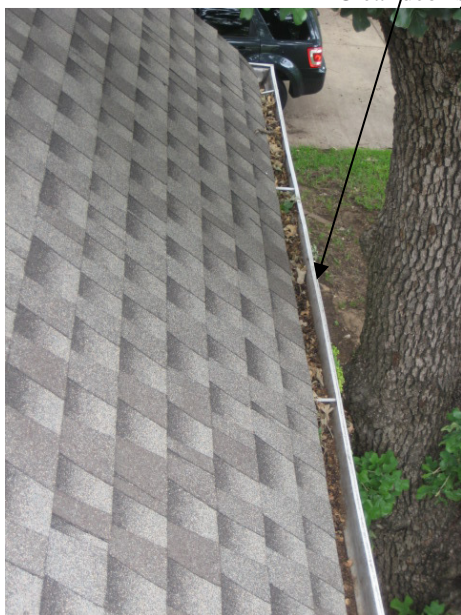
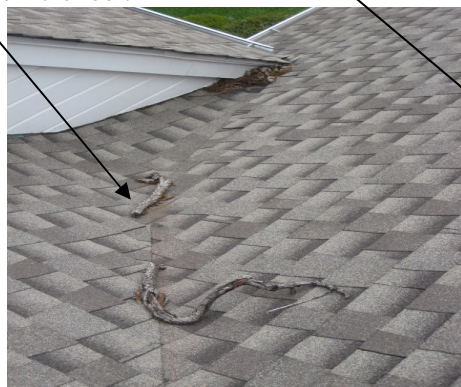
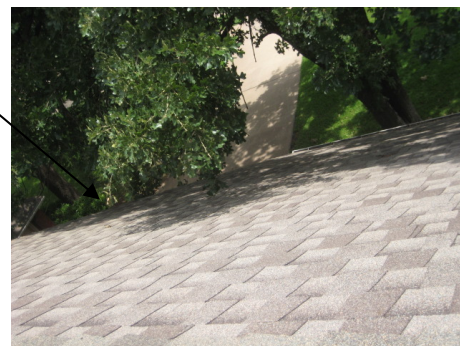
Comments: Trees are observed in contact with the roof surface. Trim tree branches away from surface. Gutters are full of debris. Clean as necessary. Clear debris from the roof.

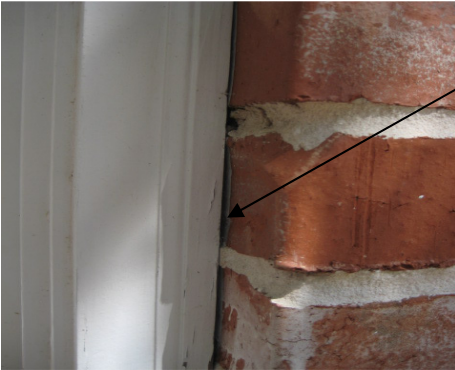
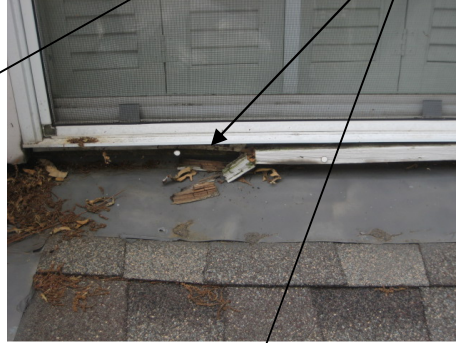
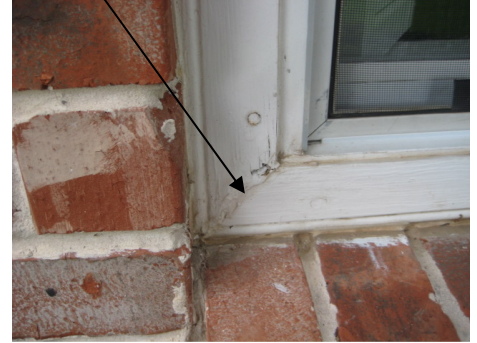
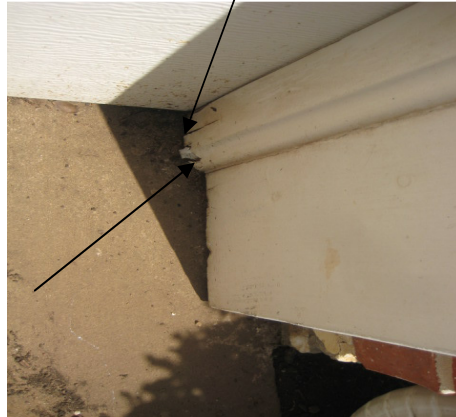
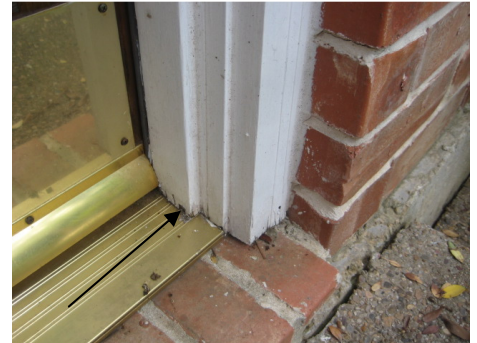
E. Walls (Interior & Exterior) *Comments:* Exterior- Rotted trim was noted under upper bathroom window.

Rotted trim was noted at the right side of garage doors, and front right window 2nd over from entry, and right side of garage door. Replace and repaint as necessary.

Caulk around garage doors and all windows as needed.

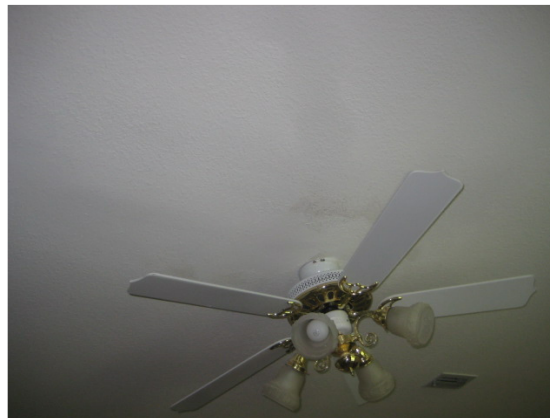
F. Ceilings & Floors *Comments:* The master bedroom ceiling appears to have previous repairs. Inquire with the seller.

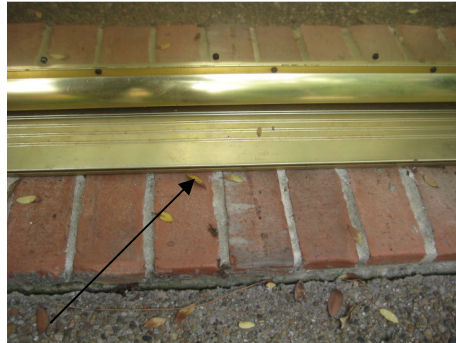
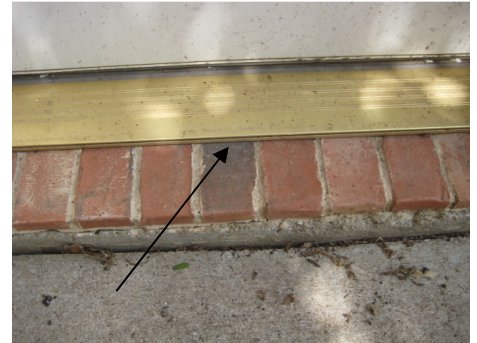
G. Doors (Interior & Exterior) Comments: Caulk around exterior door thresholds to prevent moisture intrusion.

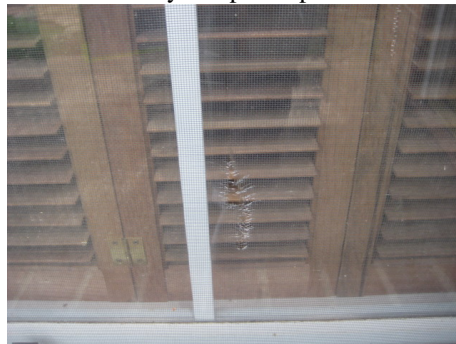
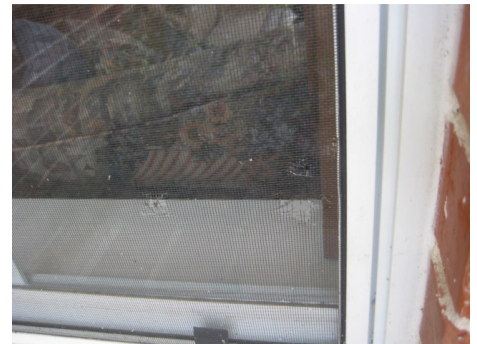
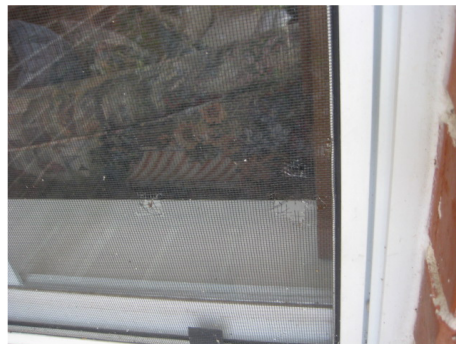
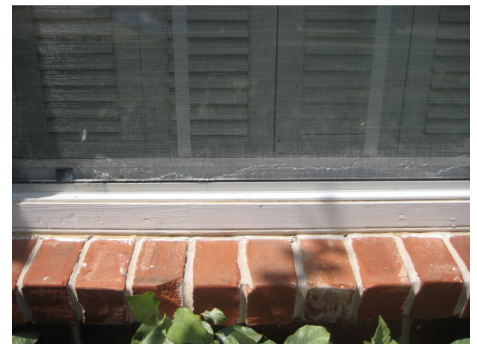
H. Windows Comments: The 2 windows in the garage exhibit signs of failed thermal seals. Replace as necessary.

There were 4 damaged screens noted- 1 by the rear French doors, 1 by the single rear entry, 1 front of garage, and 1 left of front entry. Repair/replace as necessary.

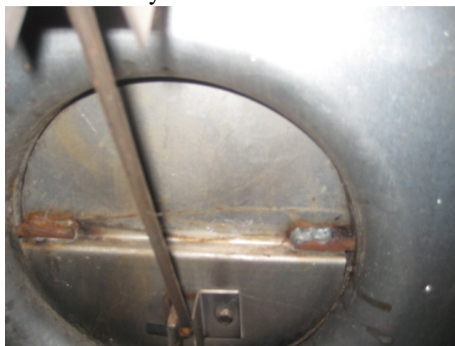
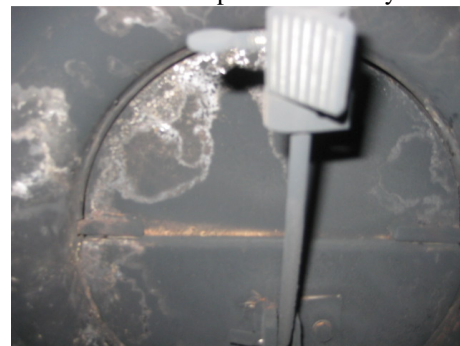
J. Fireplace/Chimney *Comments:* Gas logs are installed without the presence of damper clamps. Damper clamps are necessary to allow carbon monoxide to exit the structure. Repair as necessary.

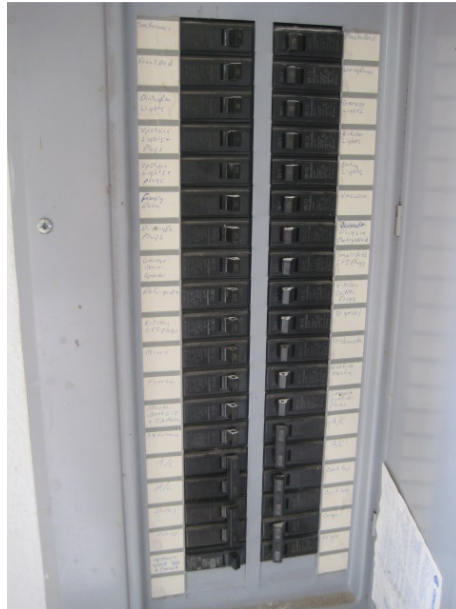
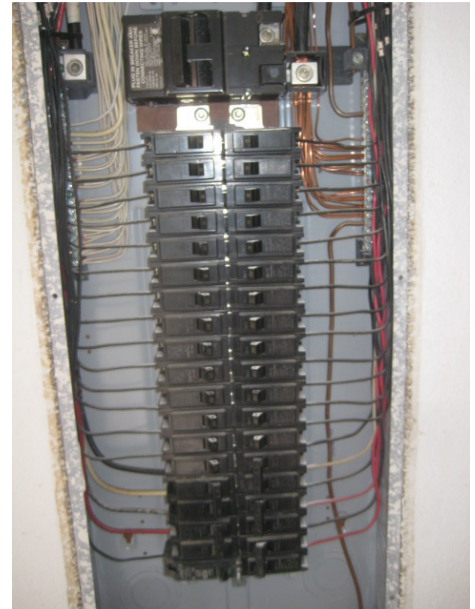
Arc fault protection is not provided by the existing circuit breakers. Arc Fault Circuit Breakers are newly developed electrical circuit breakers designed to protect against fires caused by arcing faults in the home wiring system. TREC Standards of Practice now considers lack of arc fault circuit breaker protection at all bedrooms, family rooms, hallways and closets as deficiencies. It may be desirable to upgrade the existing circuit breakers at the mentioned locations to enhance safety.

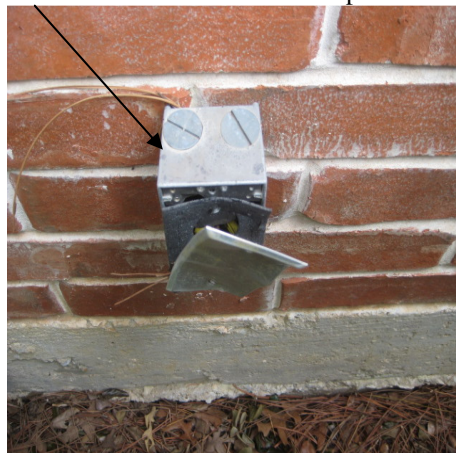
The junction box at the rear needs the weather proof cover to be replace and weather tight.

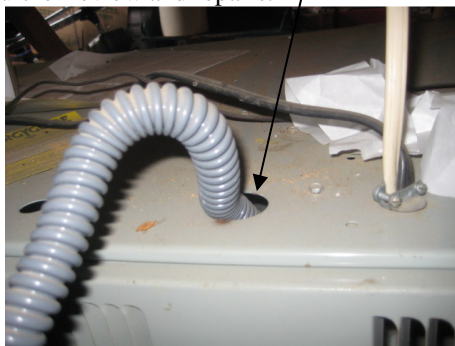
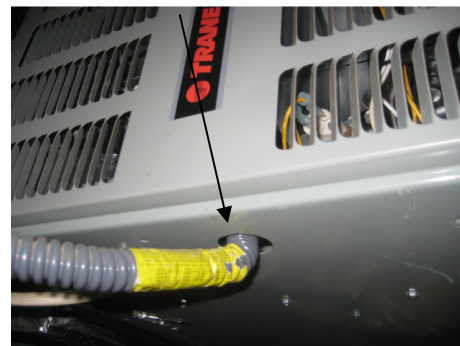
Comments: The gas flex line for the units was observed entering the plenum and could be damaged due to vibration of the unit. It is now required that the flex gas line be connected to iron gas pipe prior to entering the plenum and should be repaired to enhance safety. A licensed HVAC technician should be consulted for further review and repairs.

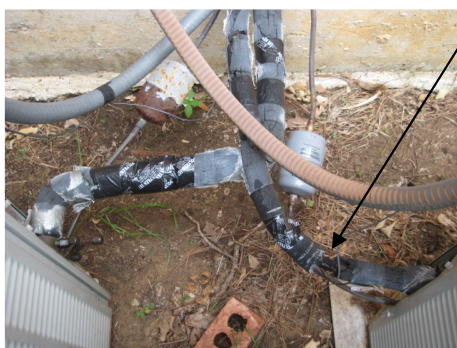
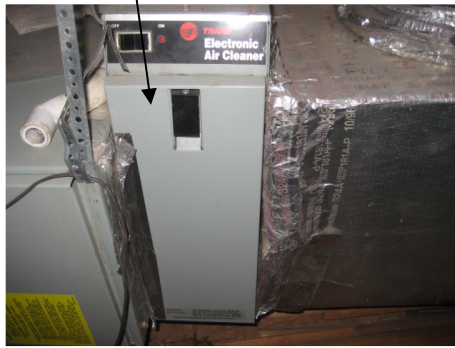
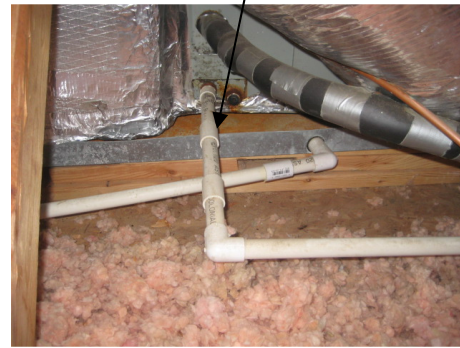
Comments: The temperature drop measured across the evaporator coil of the air conditioning system for the downstairs is lower than considered typical. This usually indicates that servicing is needed. A qualified heating and cooling technician should be consulted to further evaluate this condition and the remedies available for correction.

The electrostatic air filter for the upstairs unit does not appear to be powered on.

Condensate lines for air conditioning systems that flow into sanitary drains should be "trapped" to avoid the potential for contamination.

The insulation on the exterior suction lines is dry rotted and should be replaced.

Have the units serviced and repaired by a qualified HVAC tech.

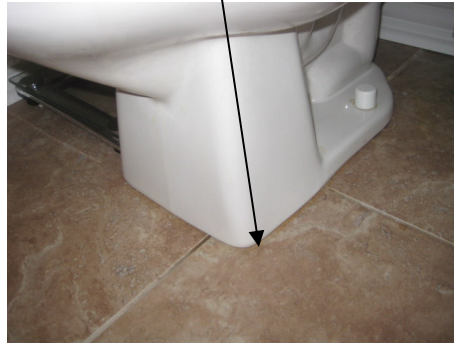
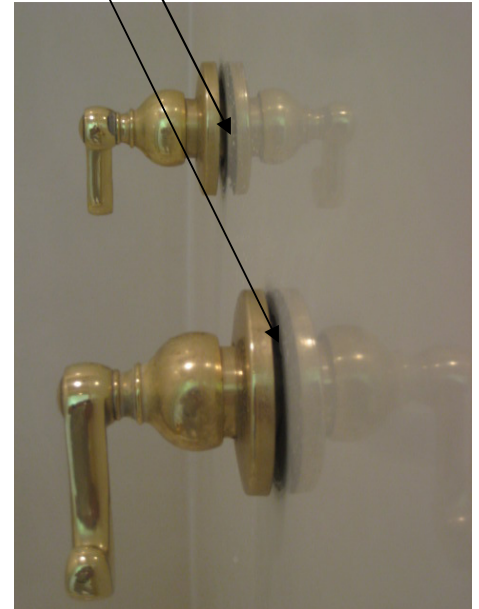
Comments: Caulk around the water controls in all bathrooms for showers and tubs.
Caulk all toilets at the base to floor.

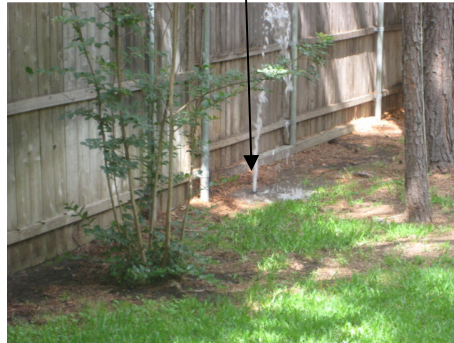
Zone 4- Rt rear- Broken/missing head. Repair as necessary
